GODDARD SPACE FLIGHT CENTER

Evaluation Report

Microcircuit (8)
Mfr.: Analog Devices
P/N: AD6640
D/C: 9951

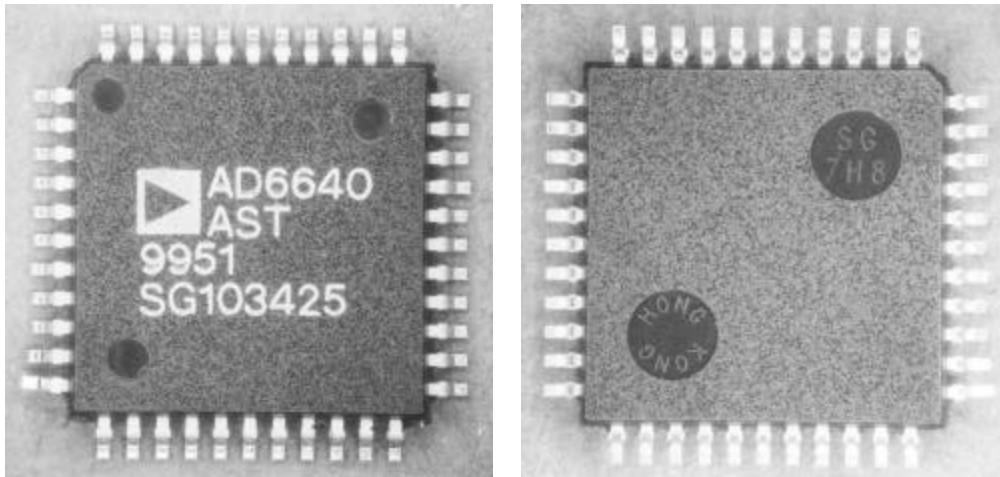
All samples were serialized (from SN 101 to SN 108) and subjected to external microscopic examination and radiography. Figure 1 gives an overall view of the part. Typical top and side X-ray views are shown Figure 2.

Figure 1. Top and bottom views of the part.

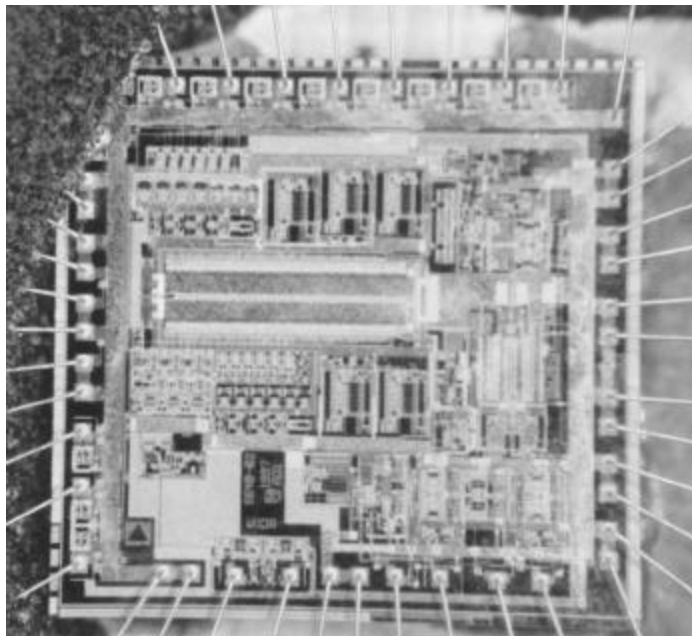
Two samples were decapsulated in red fuming nitric acid and examined microscopically. Figure 6 shows an overall view of the part after decapsulation and Figure 7 illustrates typical views of metallization patterning. No abnormalities were found except for somewhat large grains of aluminum metallization. The identification marking on the dice was "BCOM, 1997, 6640-R2".

Figure 6. Overall view of the die after decapsulation.
